Doc. No. 78-1367-10 Rev. B0

# Catalyst 1200 Series Switch Release Note for Release 4.1

**Supplement to DOC-CATALYSTUG5 (Document Number 78-1264-05)**  
**Boot Firmware Version 1.1**  
**Data Movement Processor (DMP) Flashcode Version 4.1**  
**Network Management Processor (NMP) Flashcode Version 4.1**

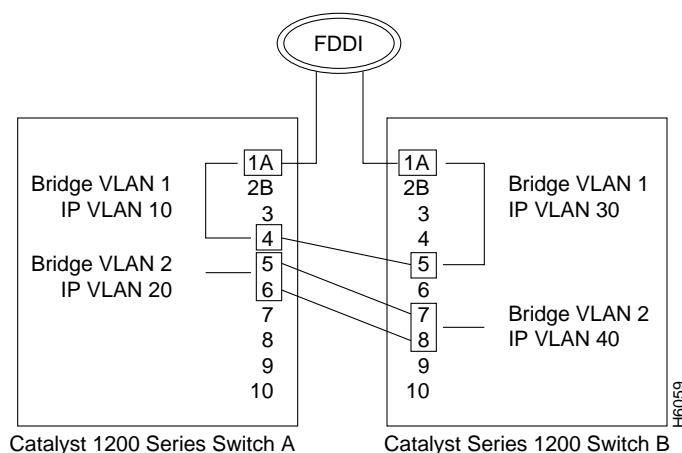
**Figure 1 Example of Catalyst 1200 Series Switches in a Looped Configuration**

- 2 When Catalyst 1200 series switches are connected in a looped configuration, you must define IP VLANs and Bridged VLANs identically on each Catalyst 1200 series switch. If these are not set correctly, the switches might not route properly.

Catalyst 1200 series switch A has ports 1 and 4 in bridge VLAN 1 and ports 5 and 6 in bridge VLAN 2. This same switch has ports 1 and 4 in IP VLAN 10 and ports 5 and 6 in IP VLAN 20. This switch is connected in a looped configuration to Catalyst 1200 series switch B.

Catalyst 1200 series switch B has ports 1 and 5 in bridge VLAN 1 and ports 7 and 8 in bridge VLAN 2. This same switch has ports 1 and 5 in IP VLAN 30 and ports 7 and 8 in IP VLAN 40.
